Some Tech Talk from Mikey

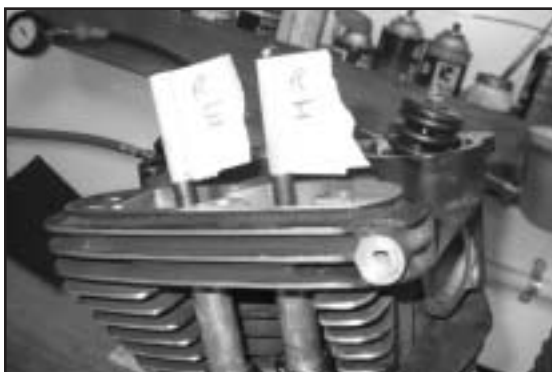
Mark parts as they are taken apart

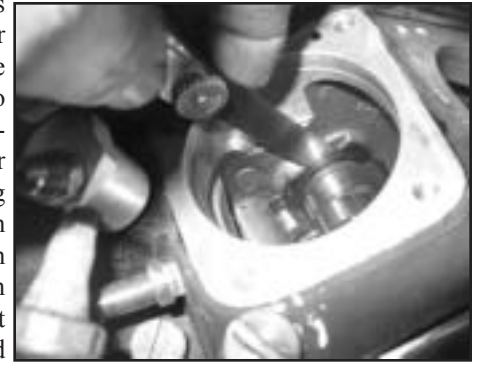
Check the camshaft end play prior to removing the cam cover.

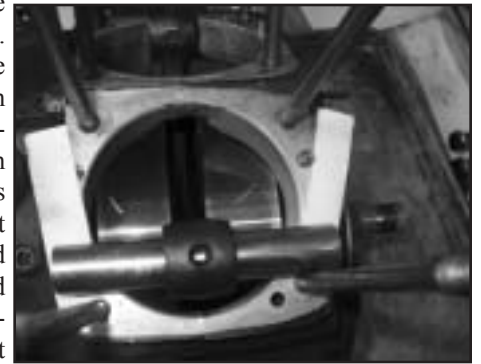
Connecting rods are then checked for straightness.

Now we remove both the cylinders and pistons off of the engine. I check for any excess physical movement in the connecting rod lower bearings, no excessive movement is felt. The connecting rods are then checked for straightness to the cases, using a long hardened precisely ground checking pin that just slides into the upper bushing in the connecting rod end and we find them pretty true. The rear has a slight twist which I will take care of now with a rod straightening fixture. Many times we find that the connecting rods are slightly bent or twisted when we take a engine apart so this is a normal operation for us. When either of these situations take place excessive wear can take place with the pistons/rings or cylinders, and excessive side thrusting of the piston wrist pin can take place, stock connecting rods can be straightened. (As an example at the shop, I have a Harley connecting rod dating from the 1970s that I have cold twisted a full 1/2 of a turn and no fracturing of the rod material is evident.) Next I remove the tappet blocks and set them aside and check the camshaft end play prior to removing the cam cover and note that measurement. I do this because if I find something unusual in the cam chest, this clearance if wrong may provide a reason why the abnormality. Then I check the flywheel end play and the run out of the flywheels at the end of the pinion shaft. I find the run out @ .0015, pretty darn good if you ask me and I cannot feel any measurable end play. As a side note, Harley accepts a run out of .012 on the flywheels in the later Twin Cams.

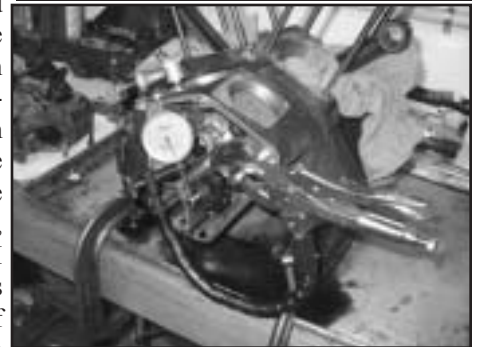
Checking Pinion Shaft Run-out
